# Hill County

## HIGH HAZARD LOCATION STUDY

Robert Peccia &  
Associates

December 1982

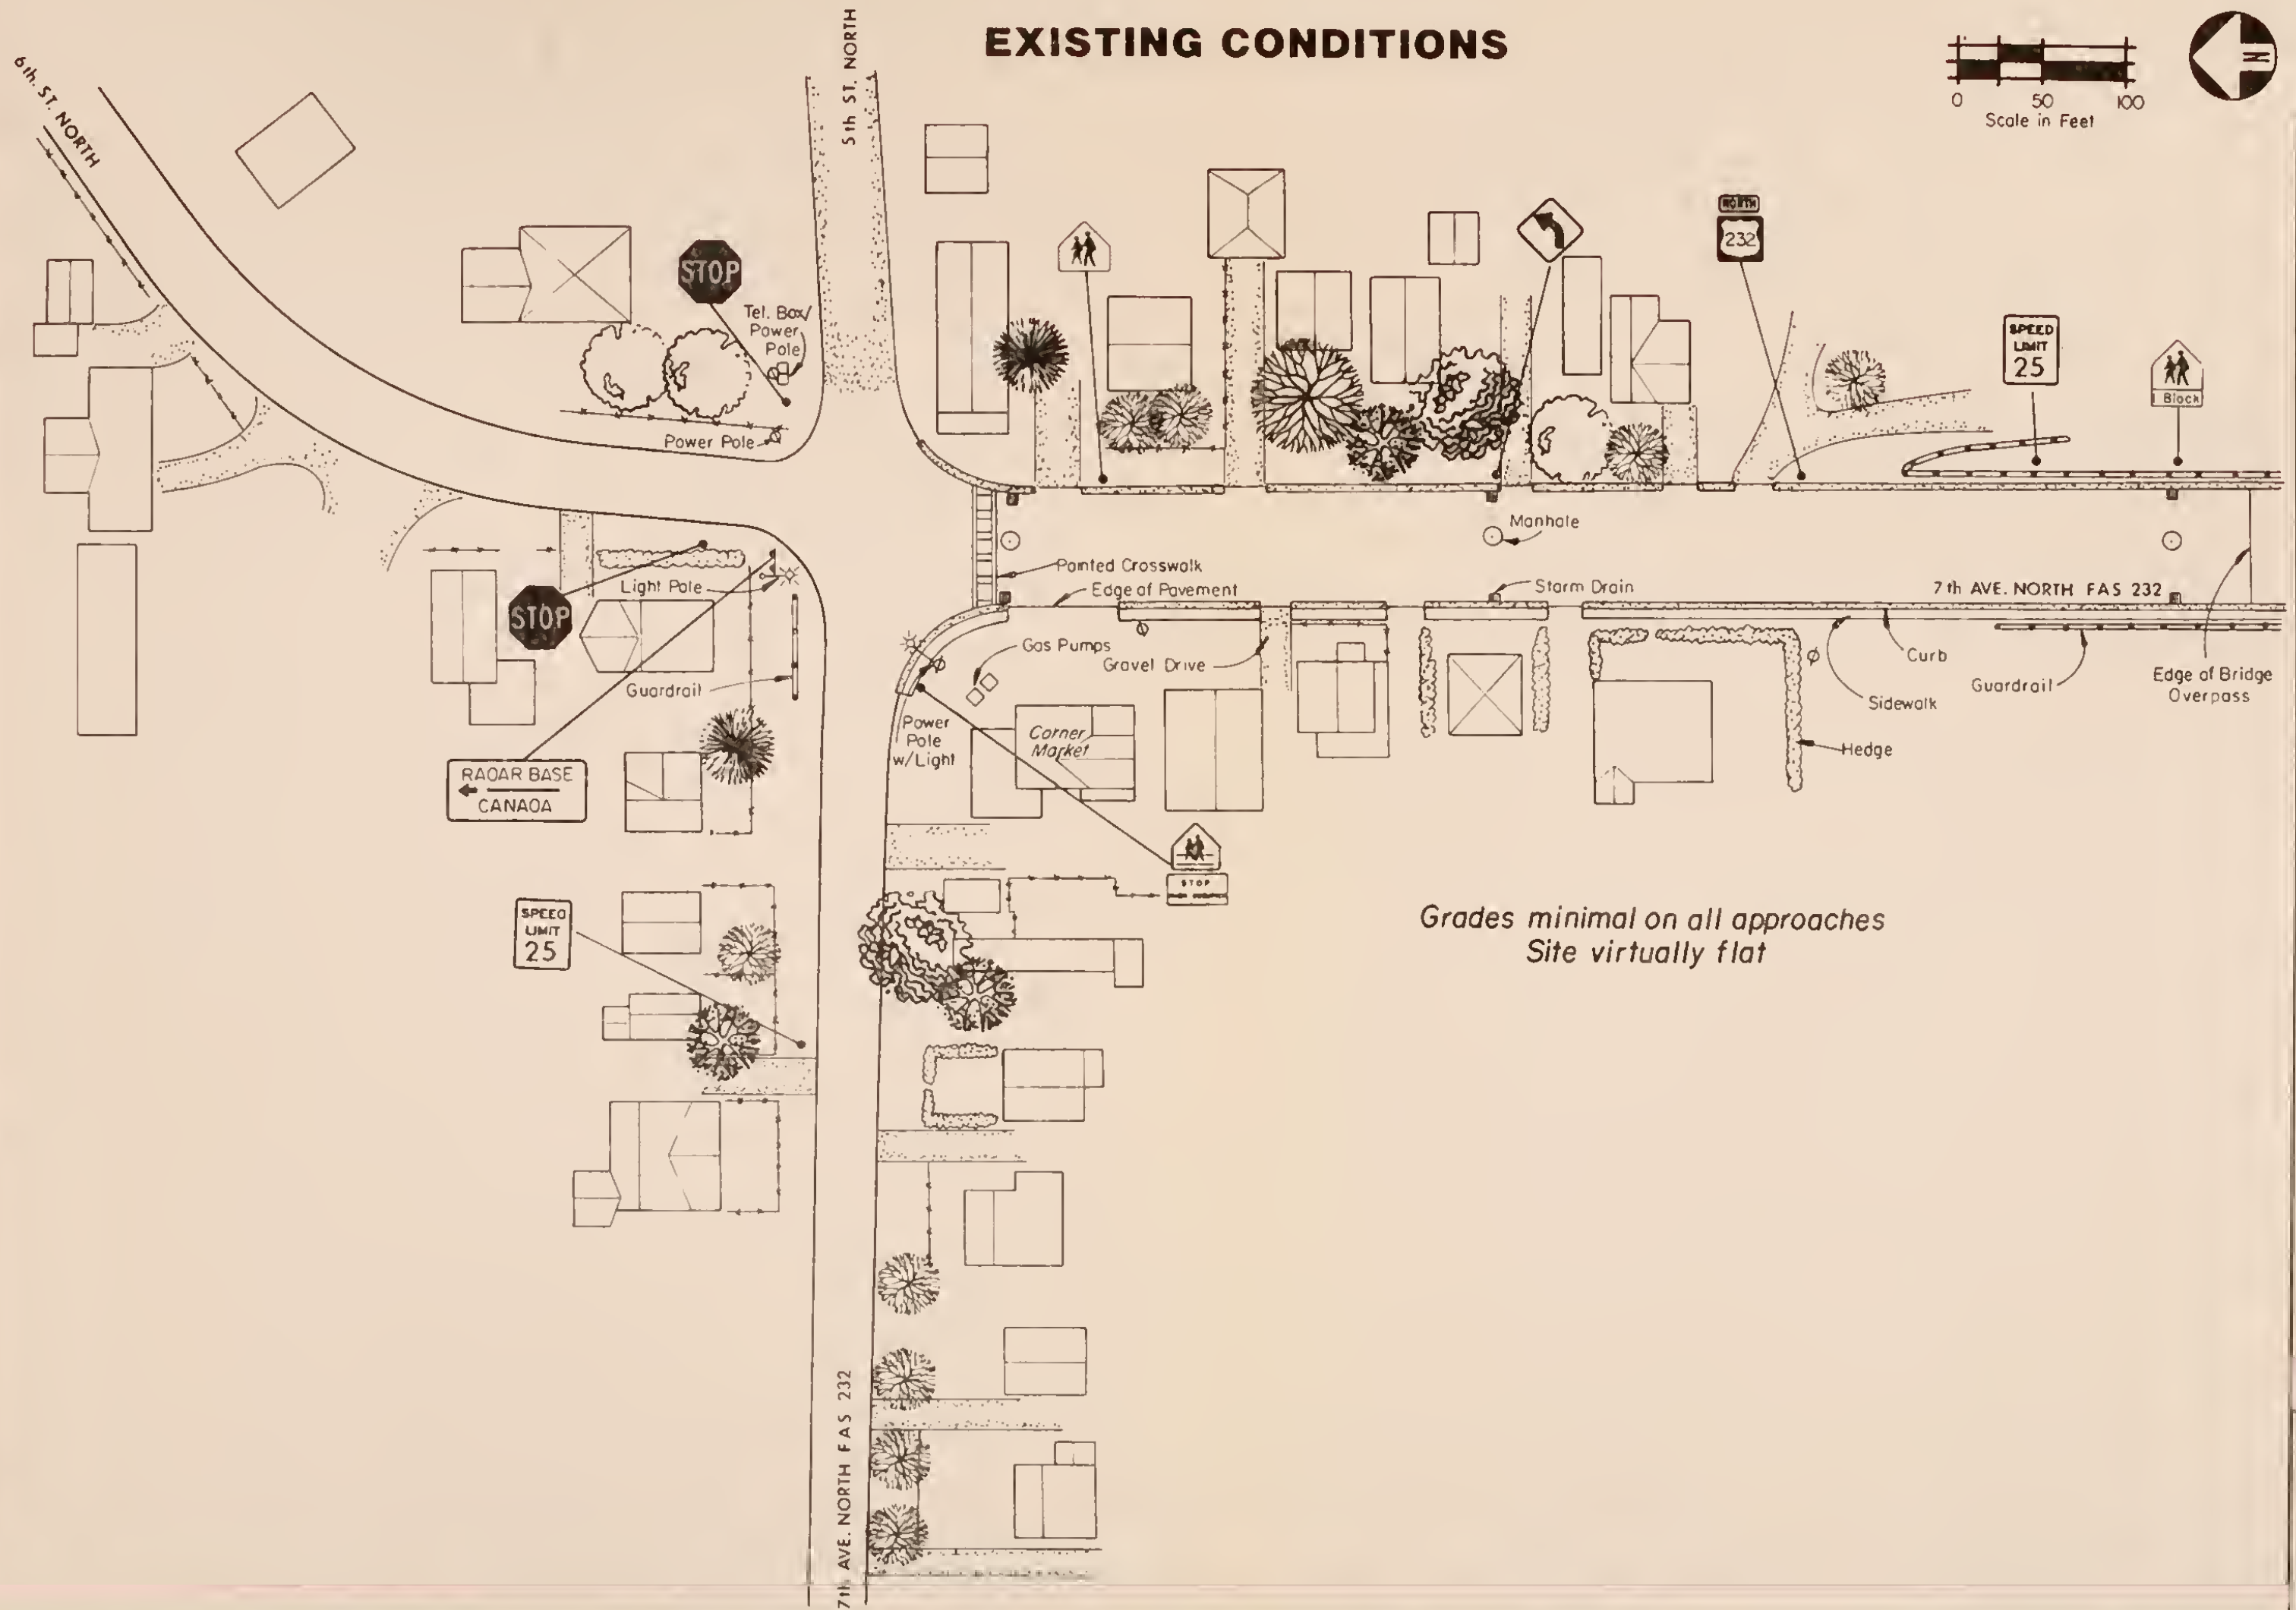
Figure No.  
**I.B**  
Hill Co.

All legs of the intersection, with the exception of 5th Street North, have asphalt pavements. Seventh Avenue North varies in width from 44 feet on the south leg where curb and gutter exists, to 24 feet on the west leg of the intersection. The grades on both the south and west approaches to the intersection are virtually flat. Both approaches have been striped; however, the pavement markings were quite worn and difficult to see at the time of the site inspection. The posted speed limit for 7th Avenue North is 25 mph. A painted crosswalk is located just south of the intersection on 7th Avenue North which is used heavily by local residents patronizing a corner grocery store and by school children travelling to and from the school bus stop on the east side of the intersection. Signing on the south leg of the intersection includes "Pedestrian Crossing - 1 Block", "Speed Limit 25", a curve warning sign, and a "Pedestrian Crossing" sign at the crosswalk. Signing on the west approach includes a "Pedestrian Crossing - 1 Block" sign located approximately 650 feet from the intersection and a "Pedestrian Crossing - Stop When Occupied" sign approximately 220 feet from the intersection.

The north approach to the intersection (6th Street North) has an asphalt surface that varies slightly in width but is typically 24 feet wide. The north leg of the intersection curves sharply approximately 150 feet north of the intersection, and the surrounding vegetation severely limits sight distance in the area. A stop sign is located approximately 30 feet from the intersection. This stopping location is not adequate for viewing the intersection, and drivers tend to "nose out" to obtain a better view of oncoming traffic. A hedge growing about 15 feet from the roadway is responsible for the sight distance obstruction; however, the hedge has been trimmed to reduce the hazard.

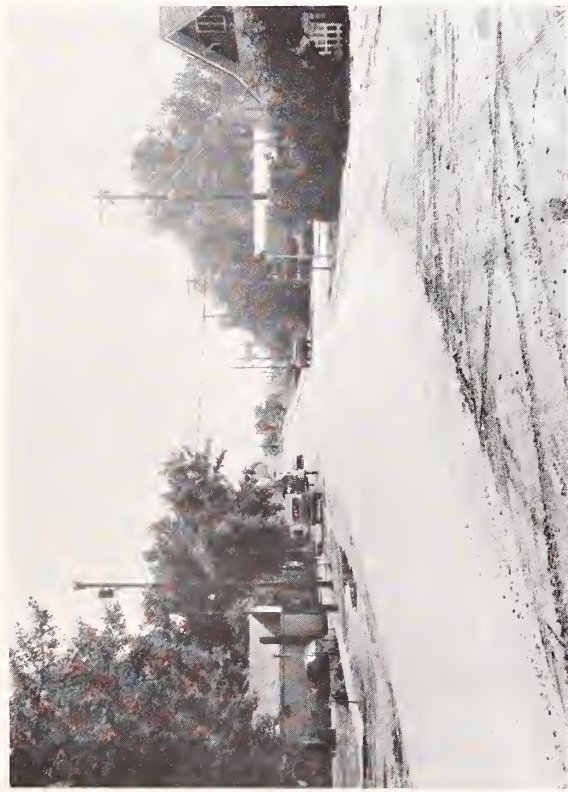
Intersection as viewed from north approach. Sight distance limitation caused by hedge at northwest corner of intersection.

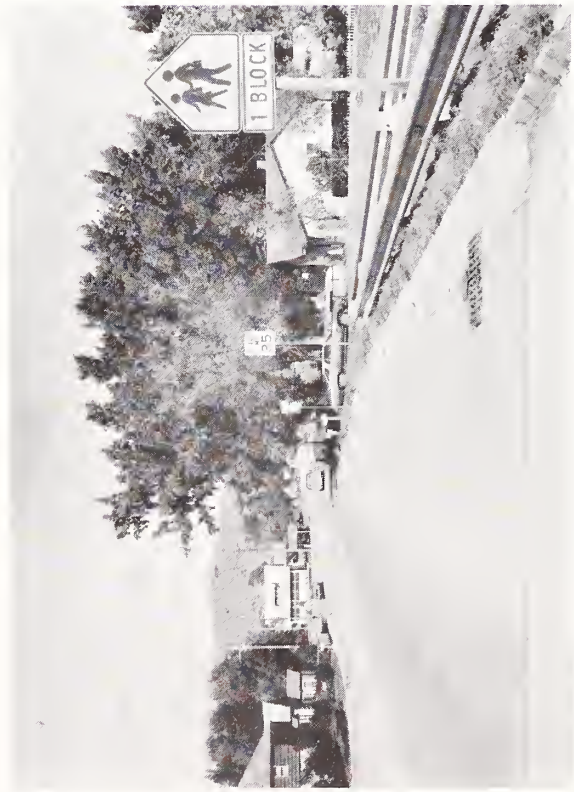
View of intersection from south approach. Note trees obstructing view of sign on east side of roadway.

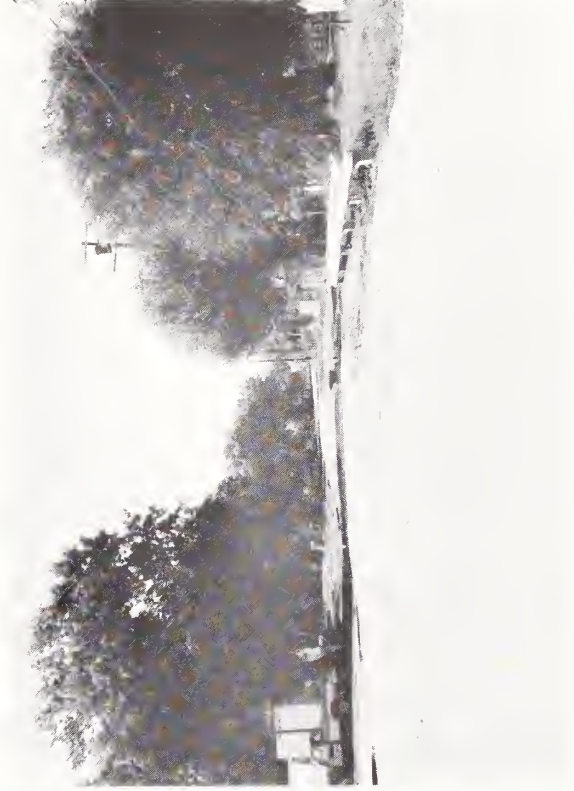
View of west approach to the intersection. Note the lack of visible pavement markings.

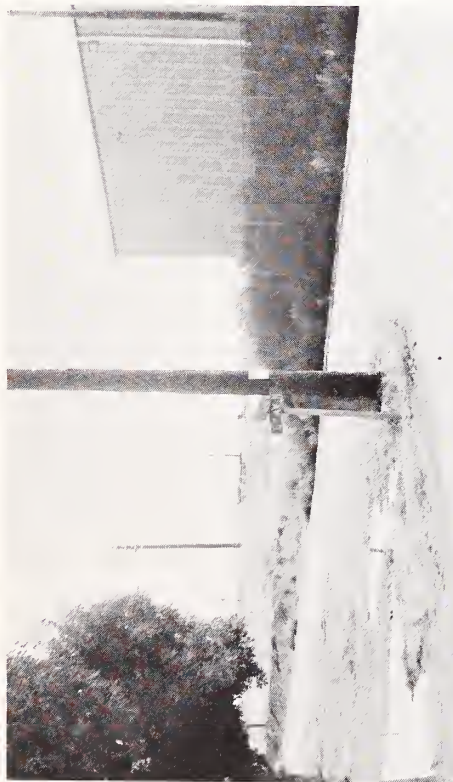
Corner of Eighth Avenue North and First Street North. Note close proximity of power pole and street sign to edge of the roadway.

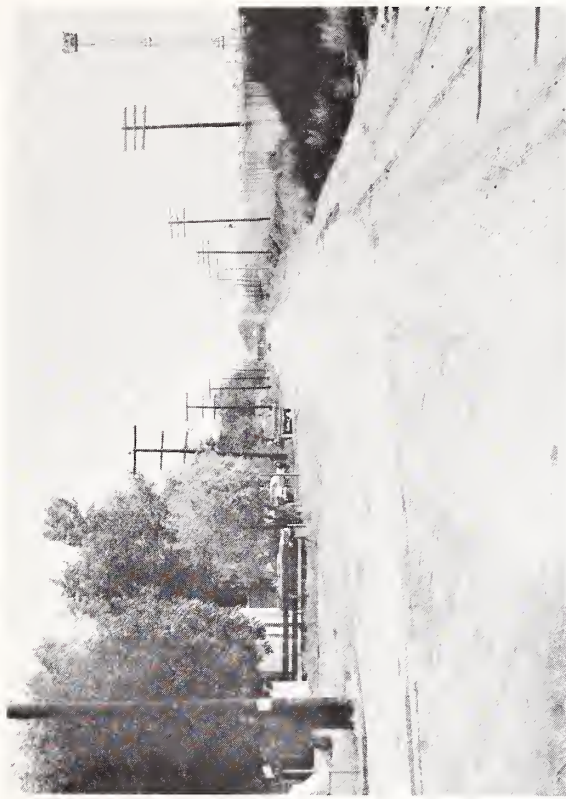
View of First Street North (Rail Street). Note long tangent section leading into the sharp corner.

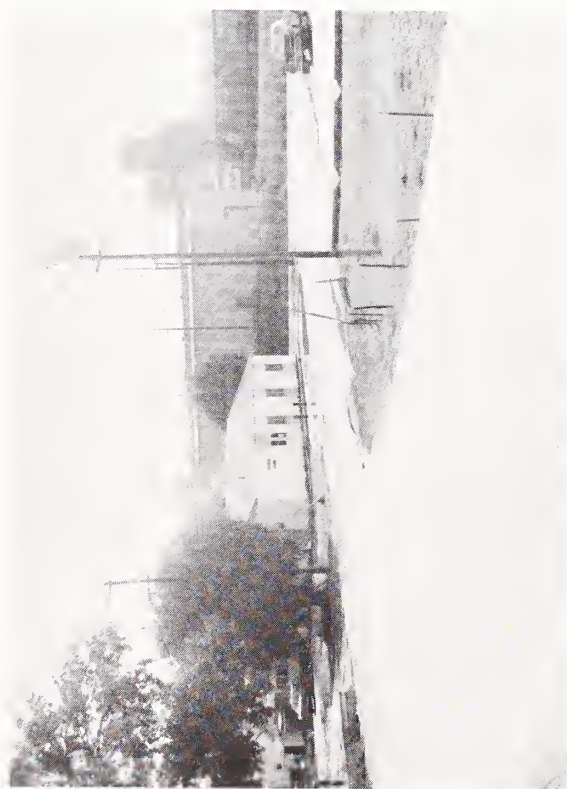
Looking southward through the site. Note the sight distance limitation caused by the Christian Armory Building. Sight distance limited to less than 150 feet at this point.

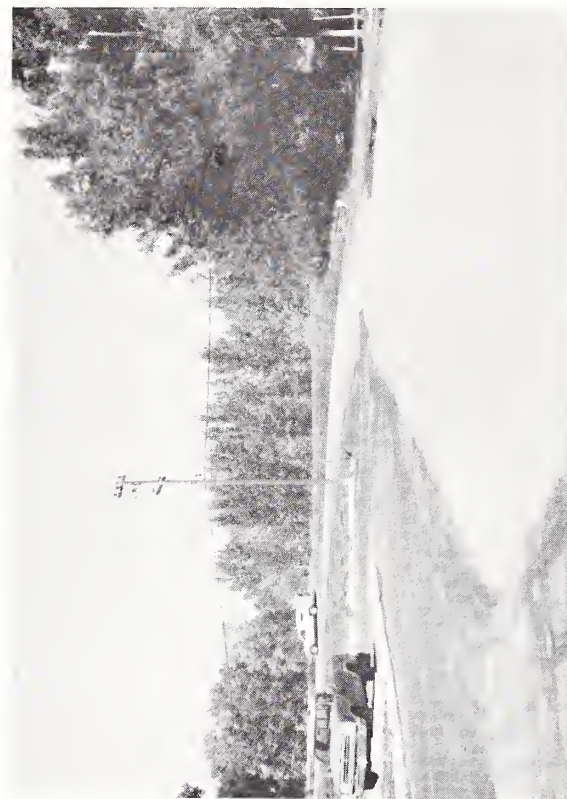
Looking northward through the site. Note grades and the lack of shoulder on the inside of the curve.

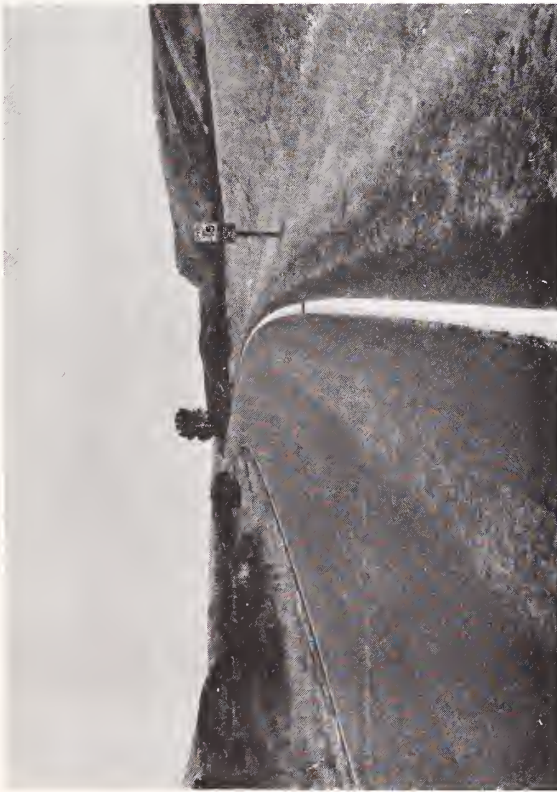
Signing and striping on Beaver Creek Road. Note non-standard "Cattle on Road" sign and basically unlimited sight distance typical to much of this site.

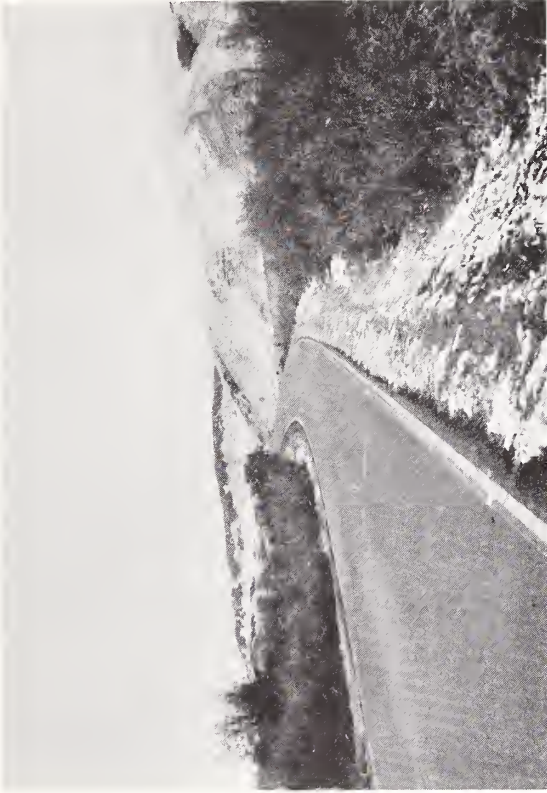
Typical area within site where roadside vegetation has been cut back through a Hill County maintenance program. This practice reduces the "hiding places" for cattle or deer near the roadway and allows cattle to move along the roadway shoulder rather than on the roadway itself.

1. In the summer of 1982, the County began a program of cutting back vegetation to 15 feet from the edge of the roadway. This is by far the most effective means of reducing vehicle/animal collisions. It is strongly recommended that this type of maintenance be continued in the future. According

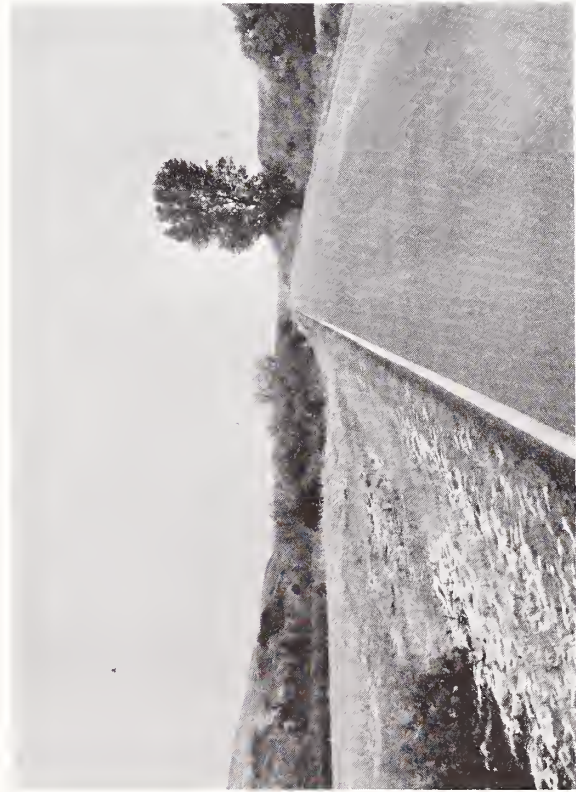
Note gently rolling terrain common to this portion of Beaver Creek Road and cattle hidden from the view of oncoming drivers by dense vegetation.

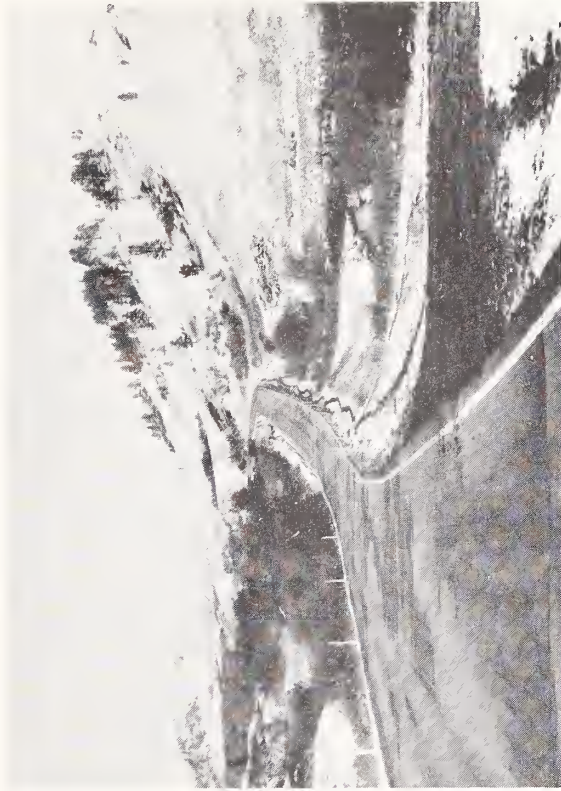
Looking northward through the site. Note the paths established along the roadway, indicating cattle movements.

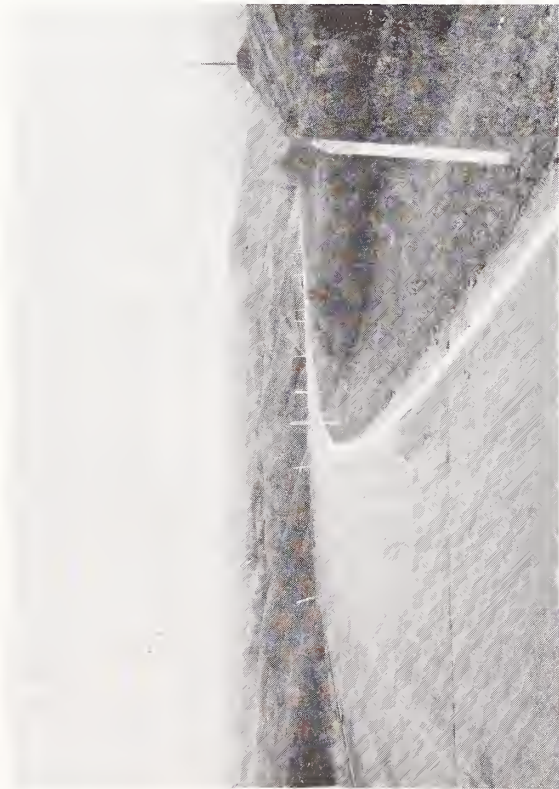
Looking north through the site from near the top of Rotary Hill. Note the steep banks adjacent to roadway shoulder and condition of several roadside delineators. The delineators appear to have been damaged when roadside vegetation was trimmed.

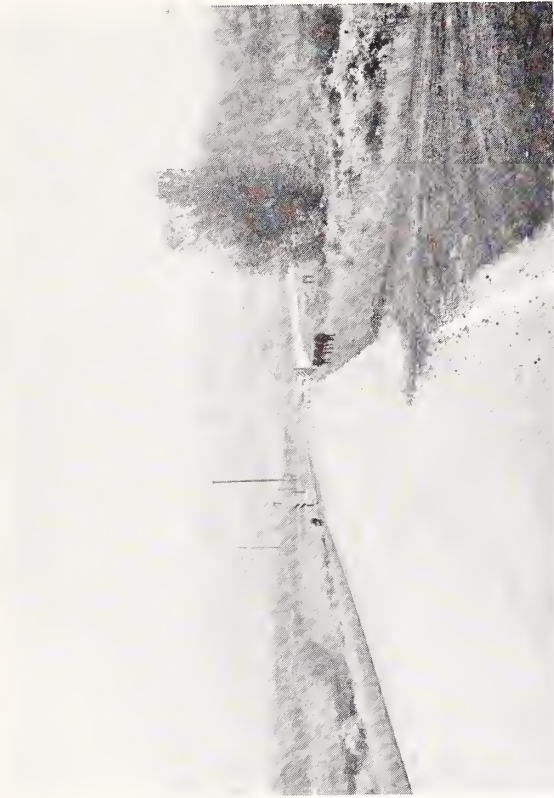
Bridge over Beaver Creek near the Mooney Coulee turnoff. Note cattle on the road and the unmatched object markers at the end of the bridge.

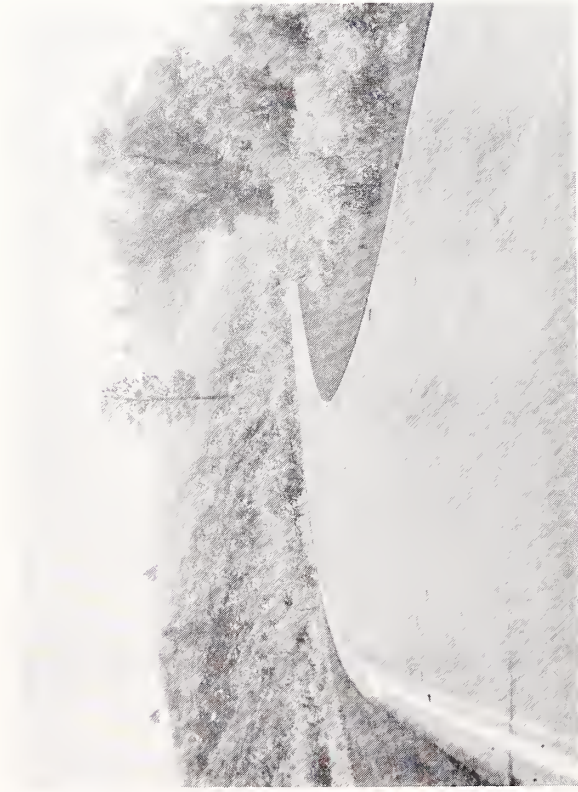
View of curve on the south approach to the site. Note the sight distance limitations caused by roadside vegetation on the inside of the curve.

3. Sight distance in the curves is somewhat limited by the adjacent trees and shrubs. It is recommended that the low branches and shrubs that restrict motorists' vision in these curves be pruned back. Trimming of roadside vegetation should be included in the annual maintenance program for this section of road.

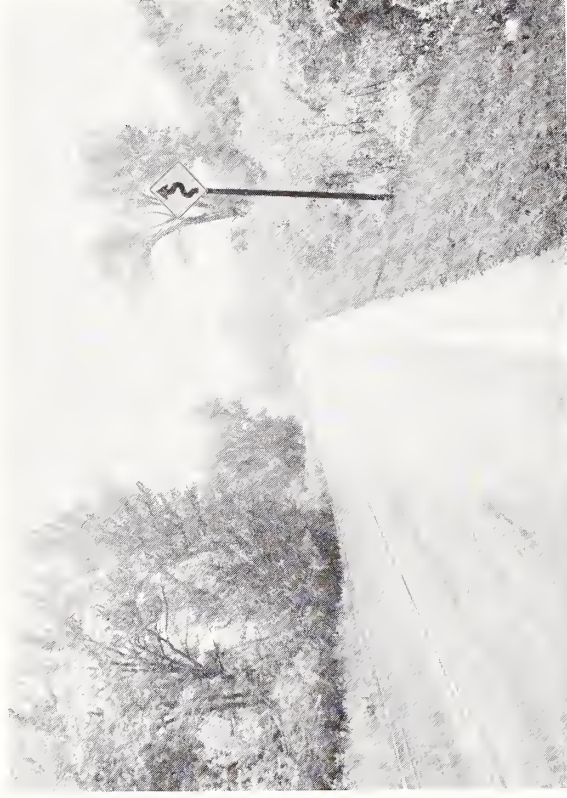
South approach to Mooney Coulee site. Note trimmed vegetation and the height at which the curve warning sign is mounted.
